DEPARTMENT OF TRANSPORTATION**DIVISION OF ENGINEERING SERVICES**

Quality Assurance and Source Inspection

Contract #: 04-0120F4Cty: SF/ALA Rte: 80 PM: 13.2/13.9File #: 69.15**SOURCE INSPECTION REPORT****Resident Engineer:** Pursell, Gary**Address:** 333 Burma Road**City:** Oakland, CA 94607**Report No:** SIR-000481**Date Inspected:** 01-Apr-2009**Project Name:** SAS Superstructure**OSM Arrival Time:** 0**Prime Contractor:** American Bridge/Fluor Enterprises, a JV**OSM Departure Time:** 1200**Contractor:** Zhenhua Port Machinery Company, Ltd (ZPMC), Changxing Island**Location:** Changxing Island, Shanghai

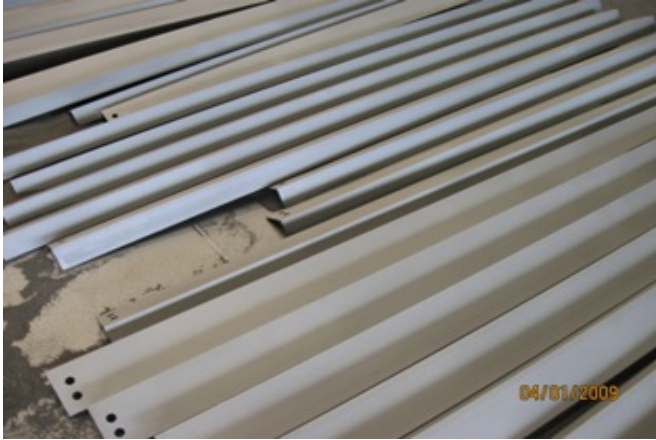
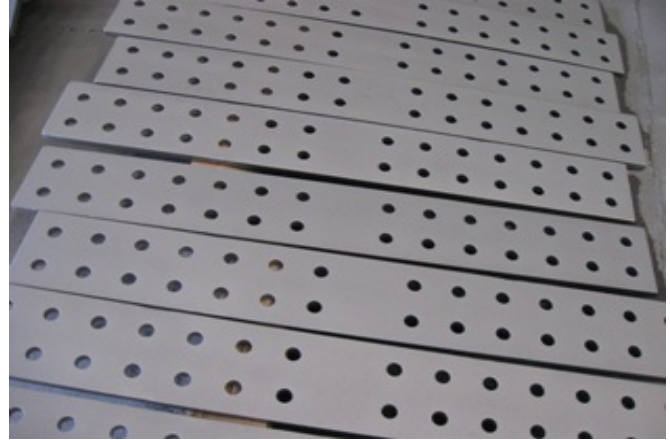
213 miscellaneous splice plates were abrasive blasted. Grinding repairs were marked by the coatings inspection staff. After grinding the plates were re-blasted. The surfaces were inspected again. The contractor was allowed to mix the Interzinc 22 primer and apply it to the plates. Ambient conditions and surface profile met the contract requirements.

Abrasive blasting was performed to repair damaged to a box beam and a diaphragm faying surface area. The pieces were not identified as to which OBG the parts go to. The blast repair was approved for coating application. The primer was applied under QA supervision.
